RI DEPARTMENT OF ENVIRONMENTAL MANAGEMENT
OFFICE OF COMPLIANCE & INSPECTION

SOLID WASTE FIELD INSPECTION REPORT

Site Name: Beausoleil, Lee & Avagyan, Artak J/T
Street Address: 175 Post Road
City/Town: Warwick State/Zip: RI Assessor's Plat/Lot: Plat 291, Lot 45

COMPLIANCE EVALUATION INSPECTION REPORT
SMALL QUANTITY GENERATOR

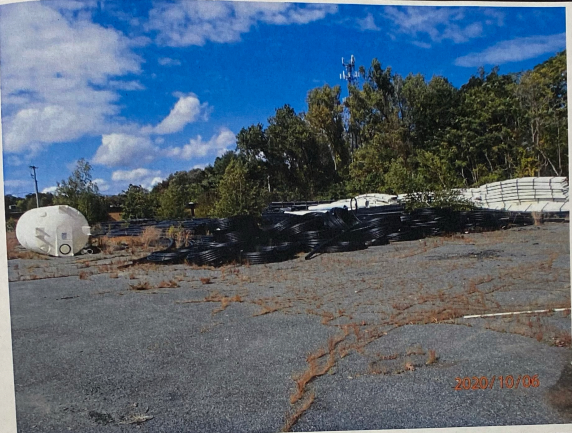
Photo # 5

The plastic tanks and pipe were also still there. I estimated that the volume of these materials is still 800 cubic yards.

Description Photo at site showing tank and pipe.

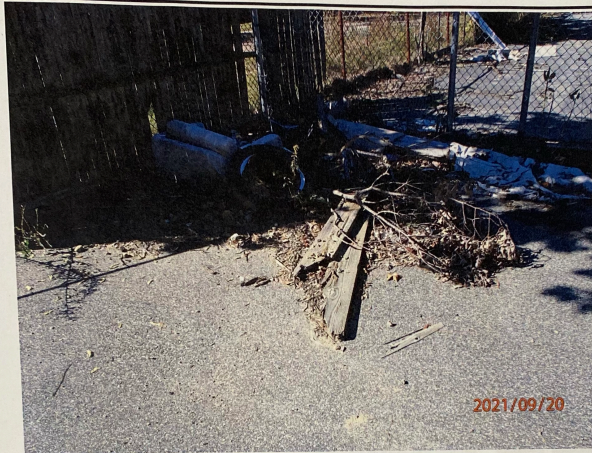
Photo # 3

I also observed approximately **2 cubic yards** of miscellaneous solid waste, such as furniture, tires, scrap lumber, white goods and other mixed solid waste.

Photo at site showing mixed solid waste.

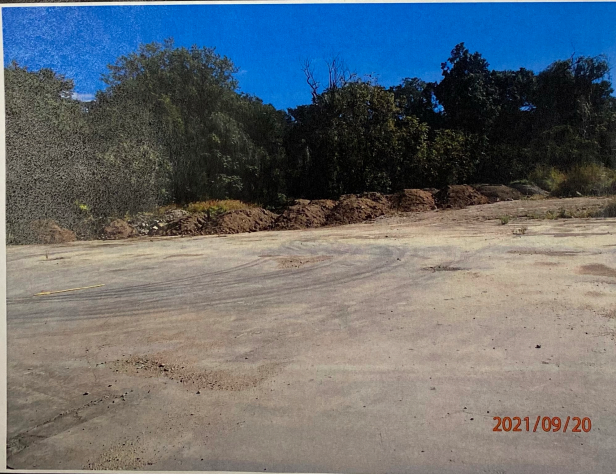
Photo # 4

I observed an area at the southeast end of the property where piles of soil were recently deposited. The soil piles were within 100 feet of a stream.

Photo at site showing soil piles.
